MITCHELL LAKE DAM  
DENT COUNTY, MISSOURI  
MO 38268

# **PHASE 1 INSPECTION REPORT NATIONAL DAM SAFETY PROGRAM**

PHASE I INSPECTION REPORT  
NATIONAL DAM SAFETY PROGRAM

Name of Dam:	Mitchell Lake Dam
State Located:	Missouri
County Located:	Dent
Stream:	Unnamed Tributary of Meramec River
Date of Inspection:	August 15, 1979

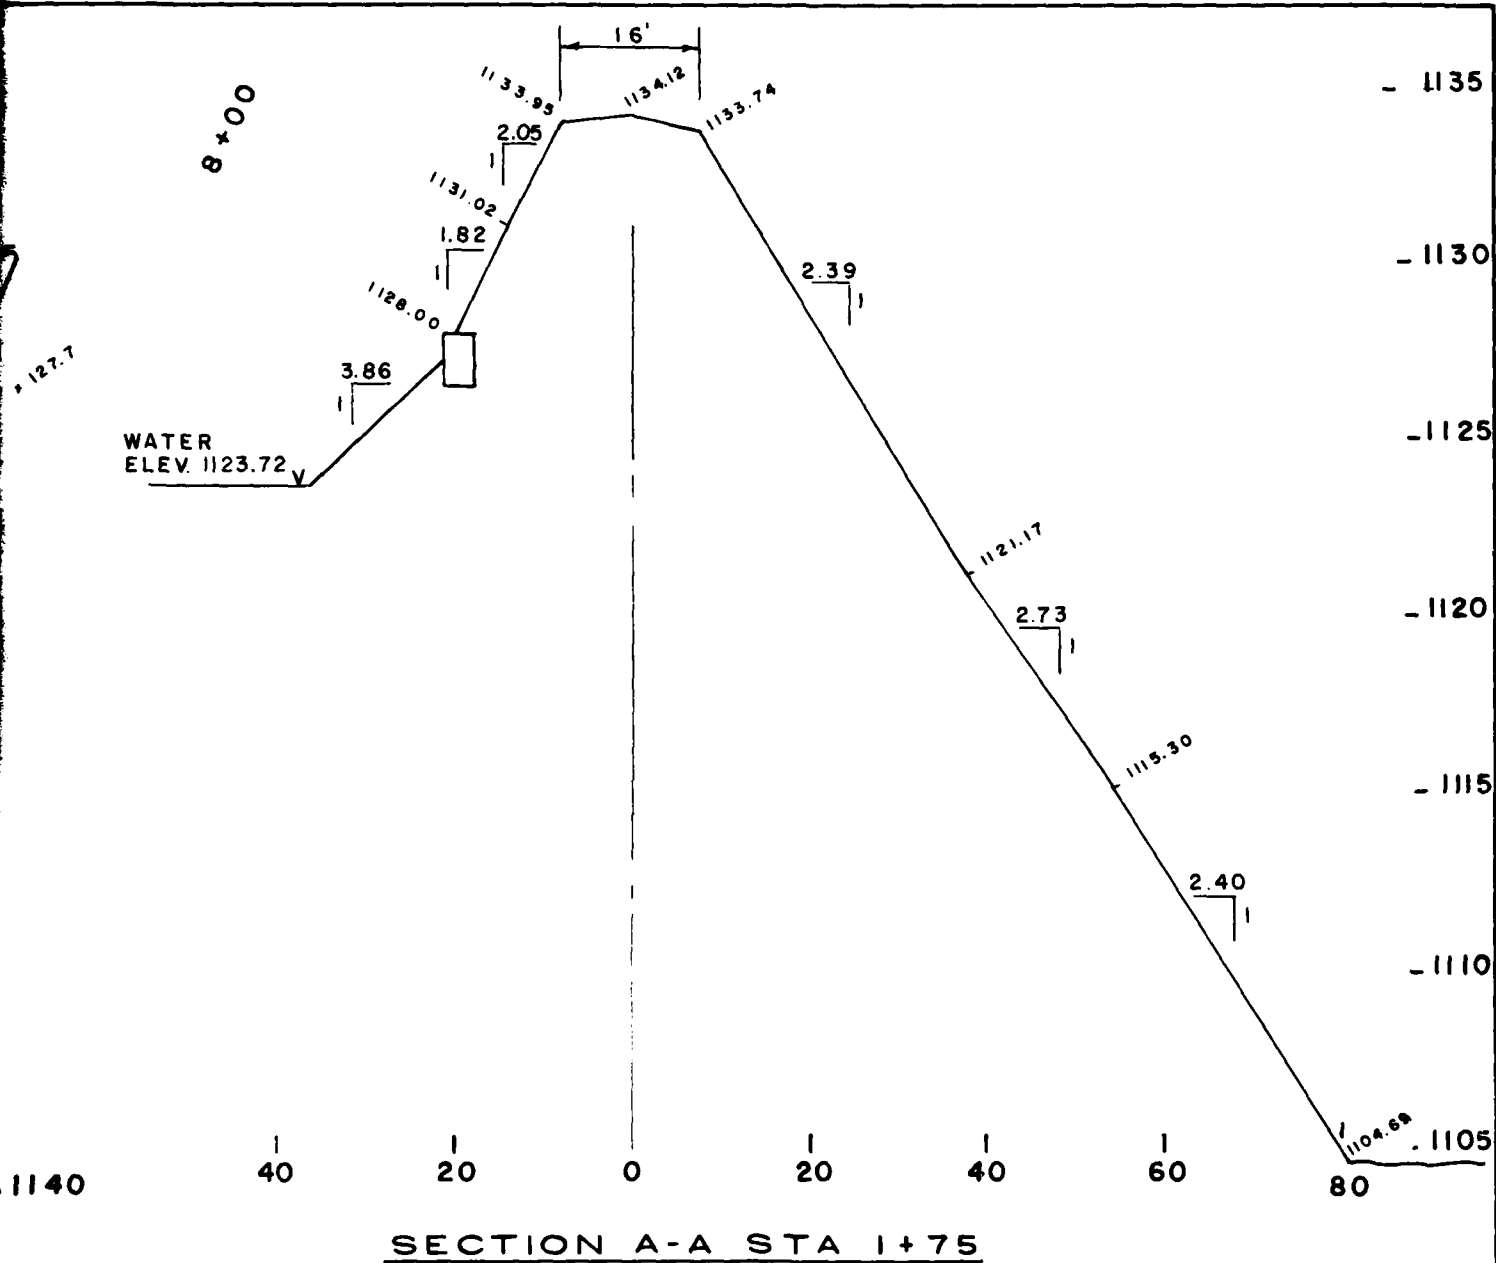
**SHEET 3 OF APPENDIX A**

The crest of the dam slopes downward to the north (see Sheet 3, Appendix A). This sloping results in about a 3 ft difference in crest elevation across its length. The horizontal alignment of the embankment is good. No surface cracks or unusual movements were noted. Some small brush growth was present on the embankment face. The owner reported that the dam is not mowed.
